MIAMI-DADE COUNTY  
DEPARTMENT OF TRANSPORTATION  
AND PUBLIC WORKS HIGHWAY DIVISION  
CONTRACT PLANS

PW PROJECT NO. 20210010 / EDP-MT-20210010  
 WORK ORDER #1

MIAMI-DADE COUNTY  
 REHABILITATION OF BEAR CUT BRIDGE OVER  
 BISCAYNE BAY/BEAR CUT, RICKENBACKER CAUSEWAY  
BRIDGE REHABILITATION PLANS

FINAL PLANS SUBMITTAL  
 AUGUST 2022

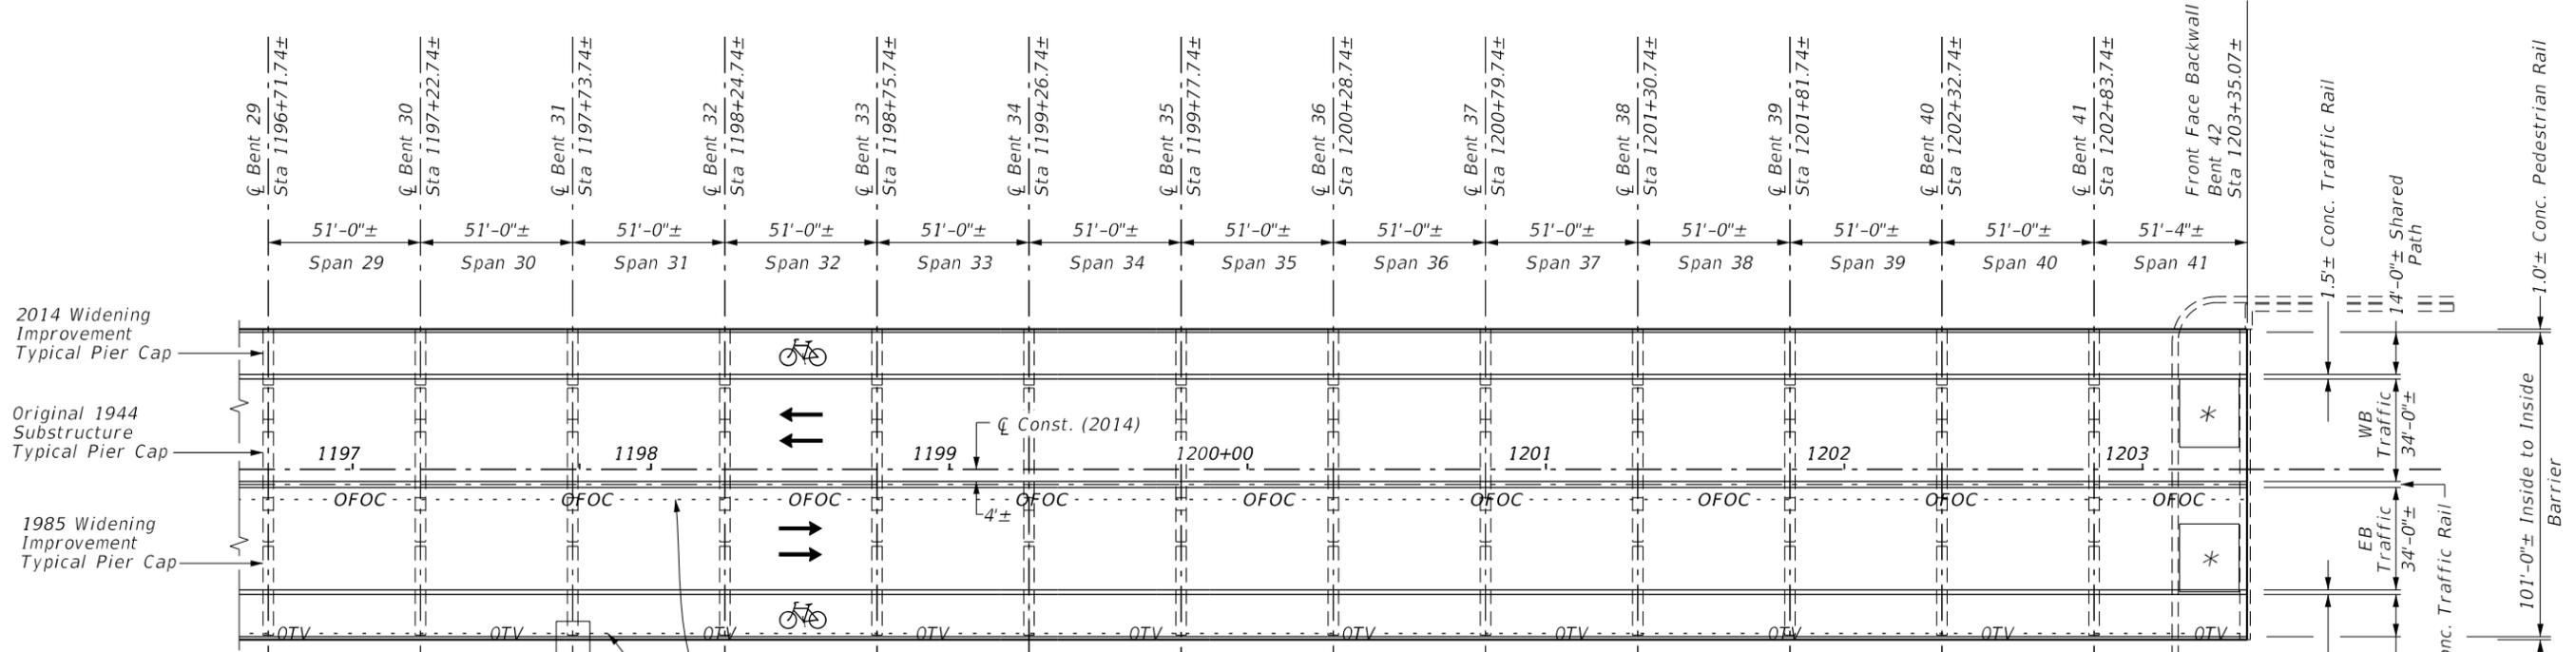
**PLAN**

Bulkhead/Existing Concrete Sea Wall  
(See Sheet S-28 for Repairs)  
(Approximate Damage under Beams 42-7 to 42-11)

Deck Repair Underside at Pier 31 -  
2 Spalls (32in.± L x 11in.± W x 5in.± D)  
(See Sheet S-12)
