SUNNY ISLES BEACH RESTORATION PROJECT: MECHANICAL DAMAGE
TO THE REEFS ADJACENT TO THE BORROW AREA

December 1988

Metro Dade Technical Report 88-14

Metro Dade Department of Environmental Resources Management

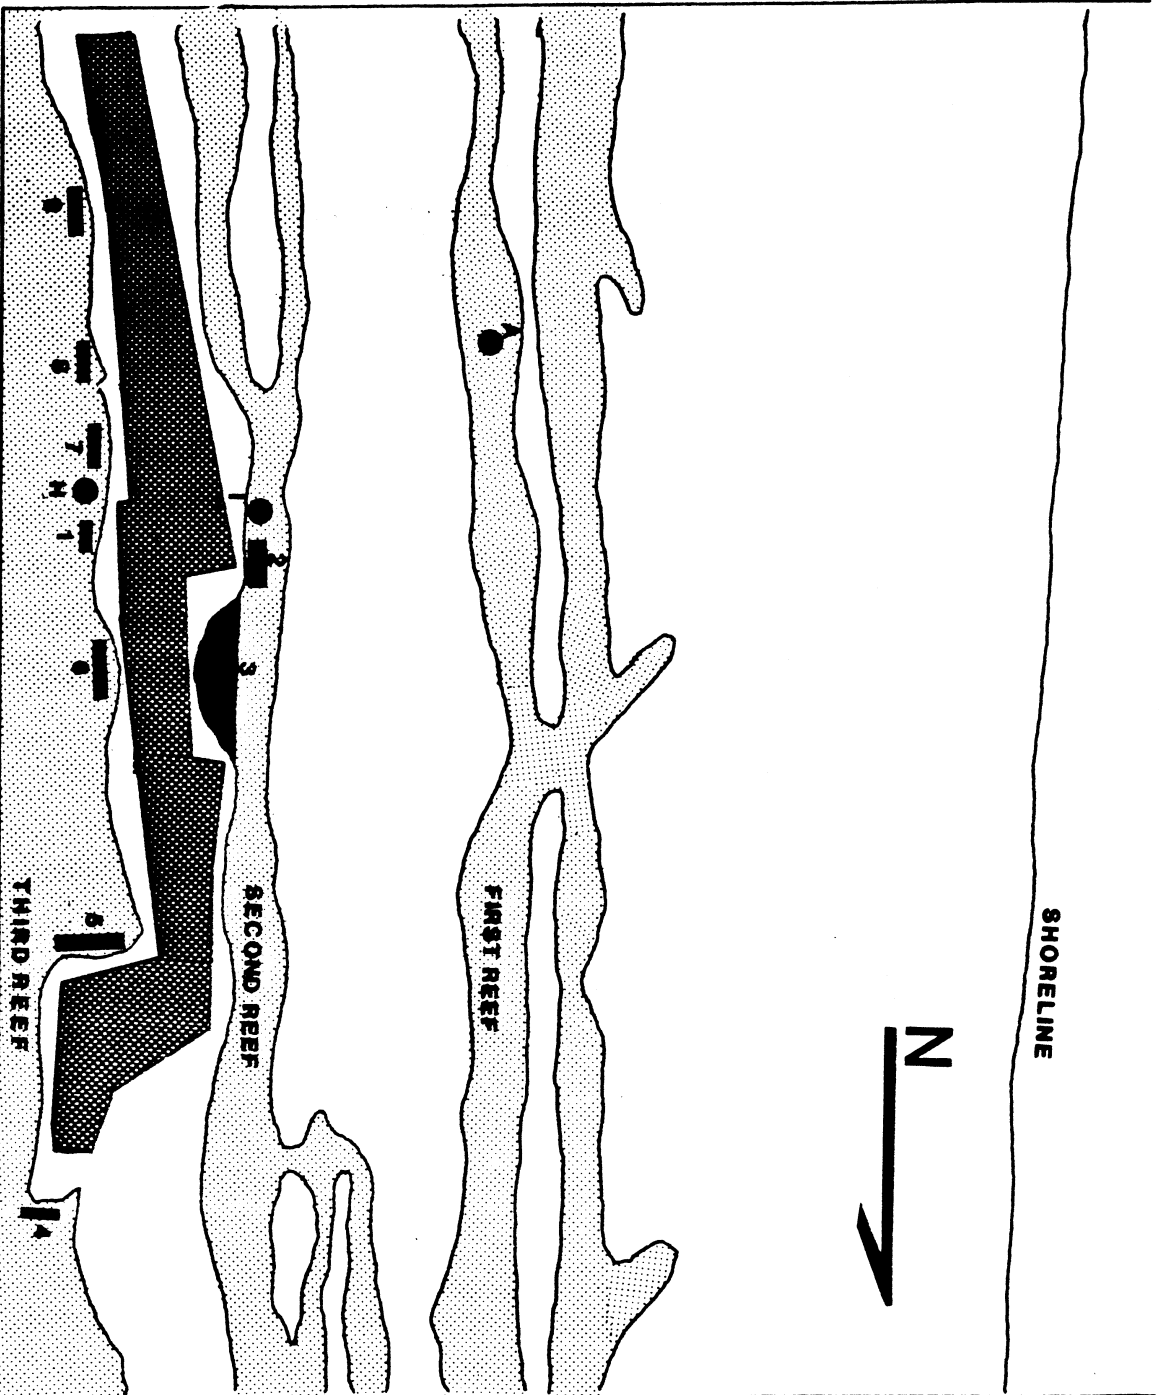
FIGURE 2

- Figure 2. Map of borrow area and reefs showing the location of the damage sites (numerals) and adjacent DERM biological monitoring stations (letters).

A total of nine areas of damage were identified on the reefs. Two sites were on the eastern edge of the second reef, and seven sites on the western edge of the third reef. The most severely damaged sites were damage sites 2 and 3 on the east side of the second reef. The approximate location of the damage sites relative to the borrow area are shown in Figure 2.

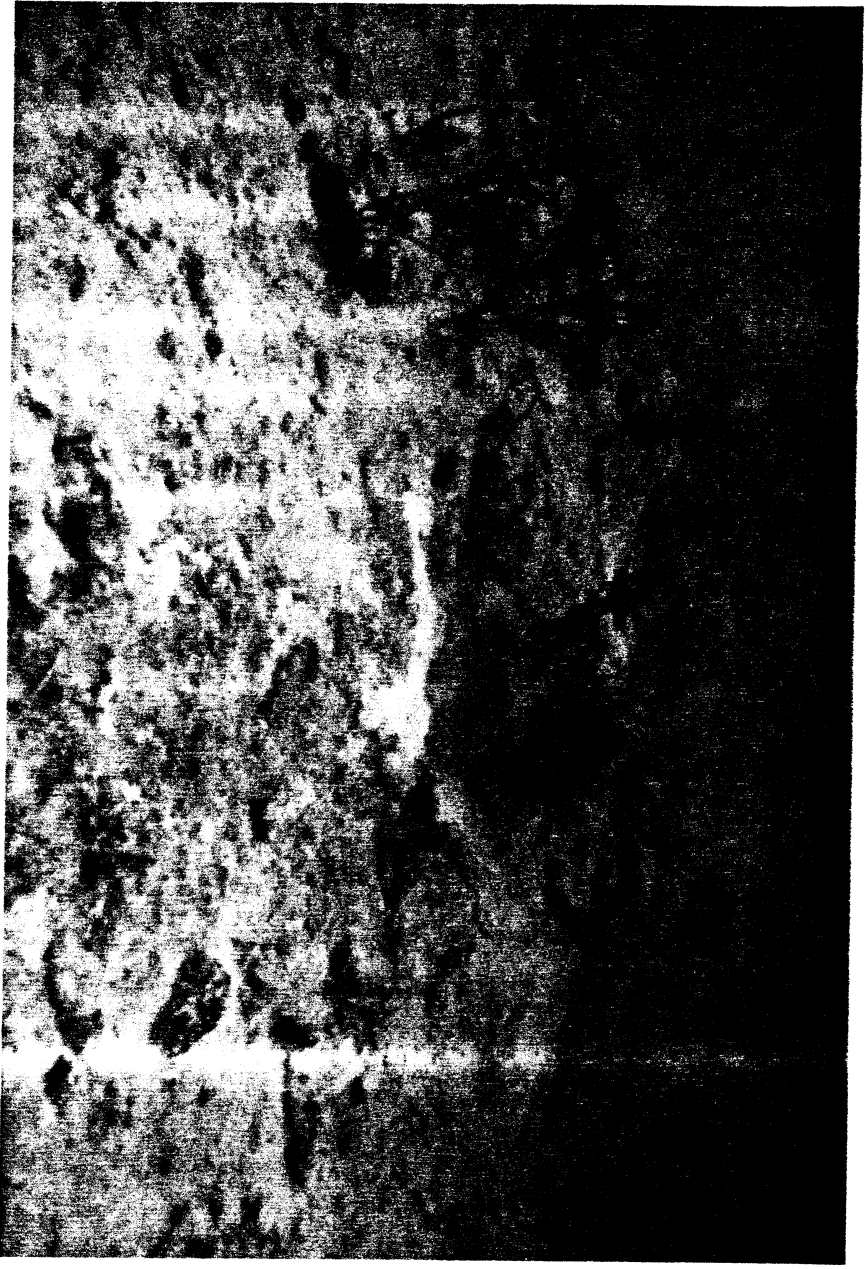
FIGURE 9

- Figure 9. Photograph of slight damage (0-25%) found adjacent to DERM biological monitoring station "H" (site 1).
- Figure 10. "Characteristic" scrape/gouge marks along the damage path at site 1 (scale is in 15 cm divisions).

In slightly and moderately damaged areas (e.g., sites 1, 4-9), damage was intermittent and limited to the highest points of the reef (Figure 9). In these areas it appeared as though the drag head of the dredge was suspended, or partially raised, and

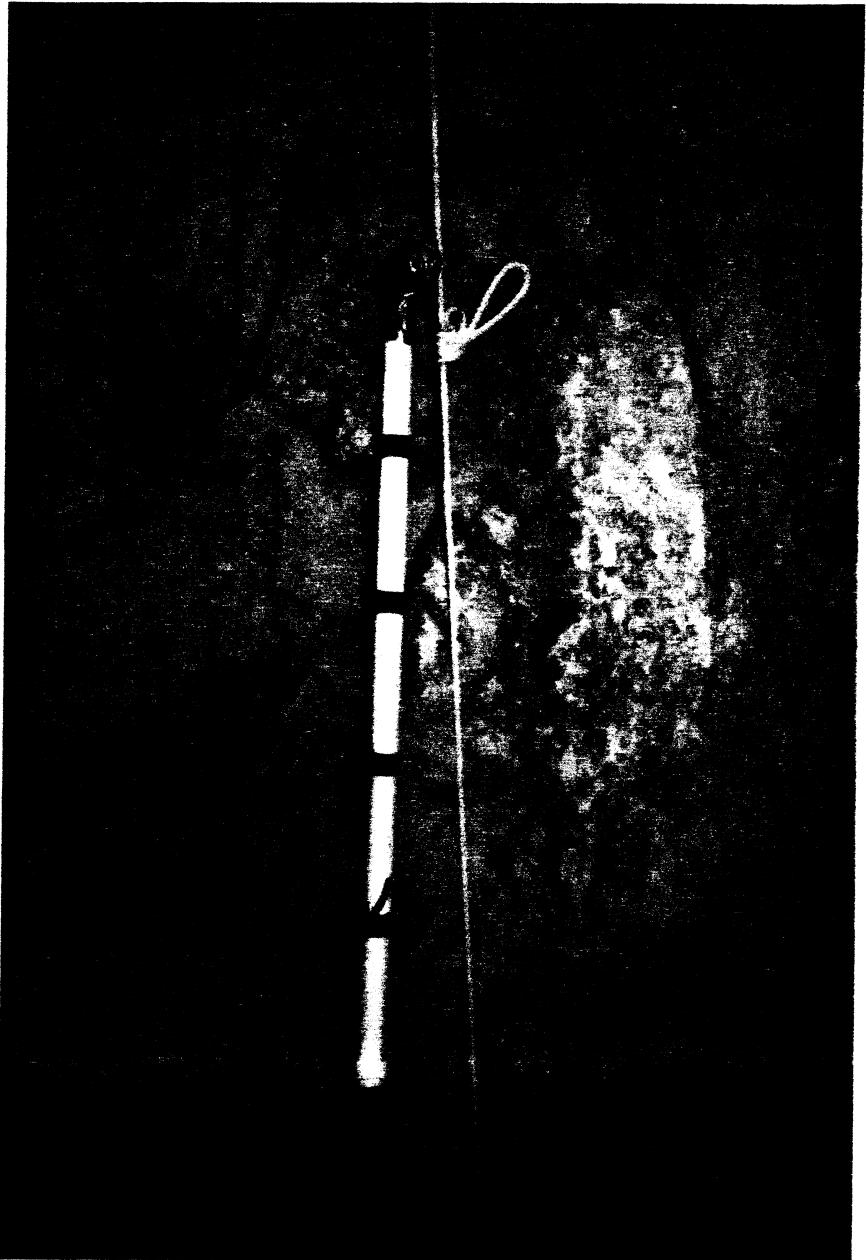
FIGURE 10

Site 1. The first damage site was found on the western edge of the third reef and crossed over DERM's biological monitoring station "H". The damage is along two converging paths, indicating multiple incidences of impact. The paths are 50-75 m long and involve slight damage (0-25%) of the hard bottom. At this specific site, two large Montastrea annularis coral heads were destroyed (Figure 11), along with a number of smaller colonies of Dichocoenia stokesii and Meandrina meandrites. The bearing of the paths were approximately 350-360/170-180 degrees.

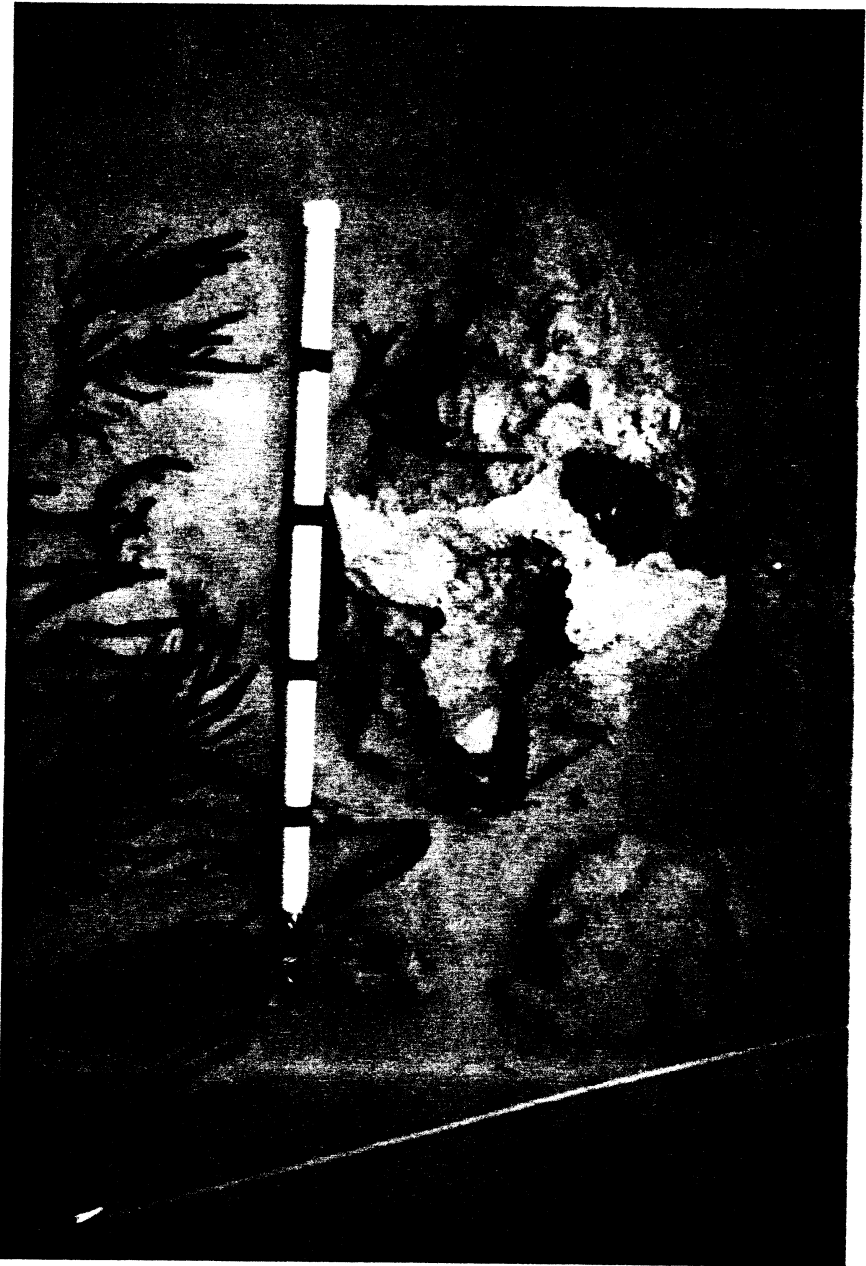
FIGURE 11

- Figure 11. Fractured Montastrea annularis head found along damaged path at site 1 (scale is in 15 cm divisions).
- Figure 12. Overturned and fractured live bottom found along the damaged path at site 1.
- Figure 13. Broken and cut sponges and soft coral indicative of the partial (slight and moderate) damage.
- Figure 14. Mosaic of the damage at site 2 generated from the measured areas of damage and their associated degree of destruction. The edge of the reef is approximated by the eastern-most points of damage.
- Figure 15. Mosaic of the damage at site 3 generated from the measured areas of damage and their associated degree of destruction. The edge of the reef is approximated by the eastern-most points of damage.

held at a constant depth in the water column. The drag head, therefore, only made contact with the portions of the reef that were shallower than the depth at which the drag head was held. Although these areas of damage were not as apparent as the severely impacted areas, the characteristic scrapings and marks were present indicating that the damage was caused by the drag head (Figure 10). Areas of partial damage often showed fractured coral heads (Figure 11) and live bottom (Figure 12), damaged soft corals and sponges (Figure 13).
