MIAMI-DADE COUNTY  
DEPARTMENT OF TRANSPORTATION  
AND PUBLIC WORKS HIGHWAY DIVISION  
CONTRACT PLANS

PW PROJECT NO. 20210010 / EDP-MT-20210010  
 WORK ORDER #1

MIAMI-DADE COUNTY  
 REHABILITATION OF BEAR CUT BRIDGE OVER  
 BISCAYNE BAY/BEAR CUT, RICKENBACKER CAUSEWAY  
BRIDGE REHABILITATION PLANS

FINAL PLANS SUBMITTAL  
 AUGUST 2022

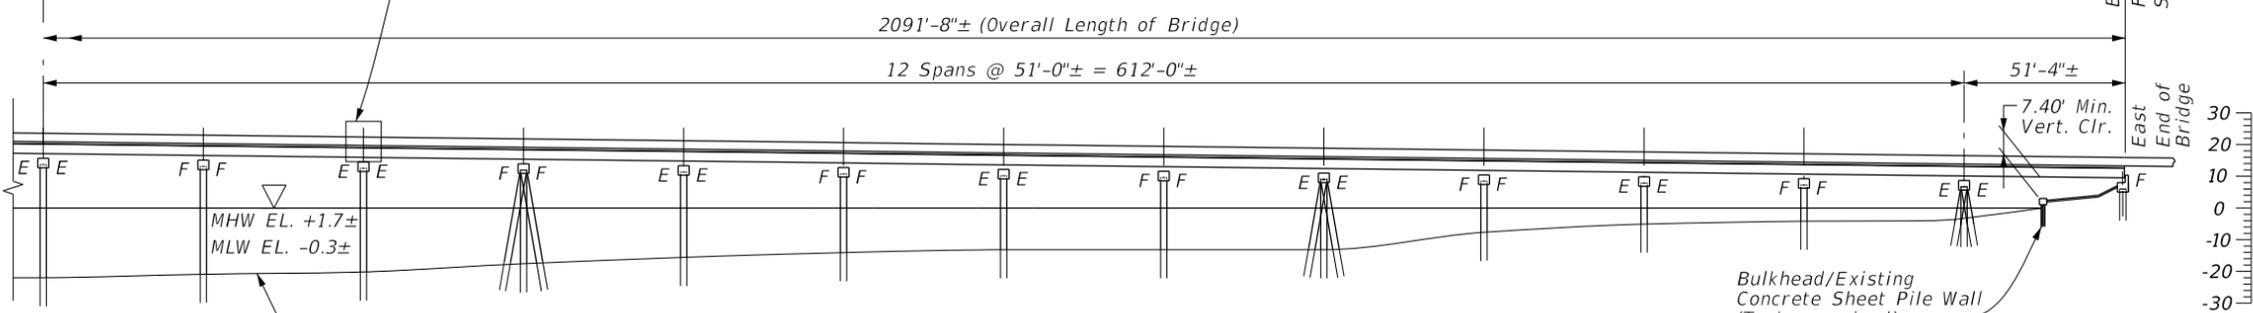
**ELEVATION**

Bulkhead/Existing Concrete Sea Wall  
(See Sheet S-28 for Repairs)  
(Approximate Damage under Beams 42-7 to 42-11)

Deck Repair Underside at Pier 31 -  
2 Spalls (32in.± L x 11in.± W x 5in.± D)  
(See Sheet S-12)

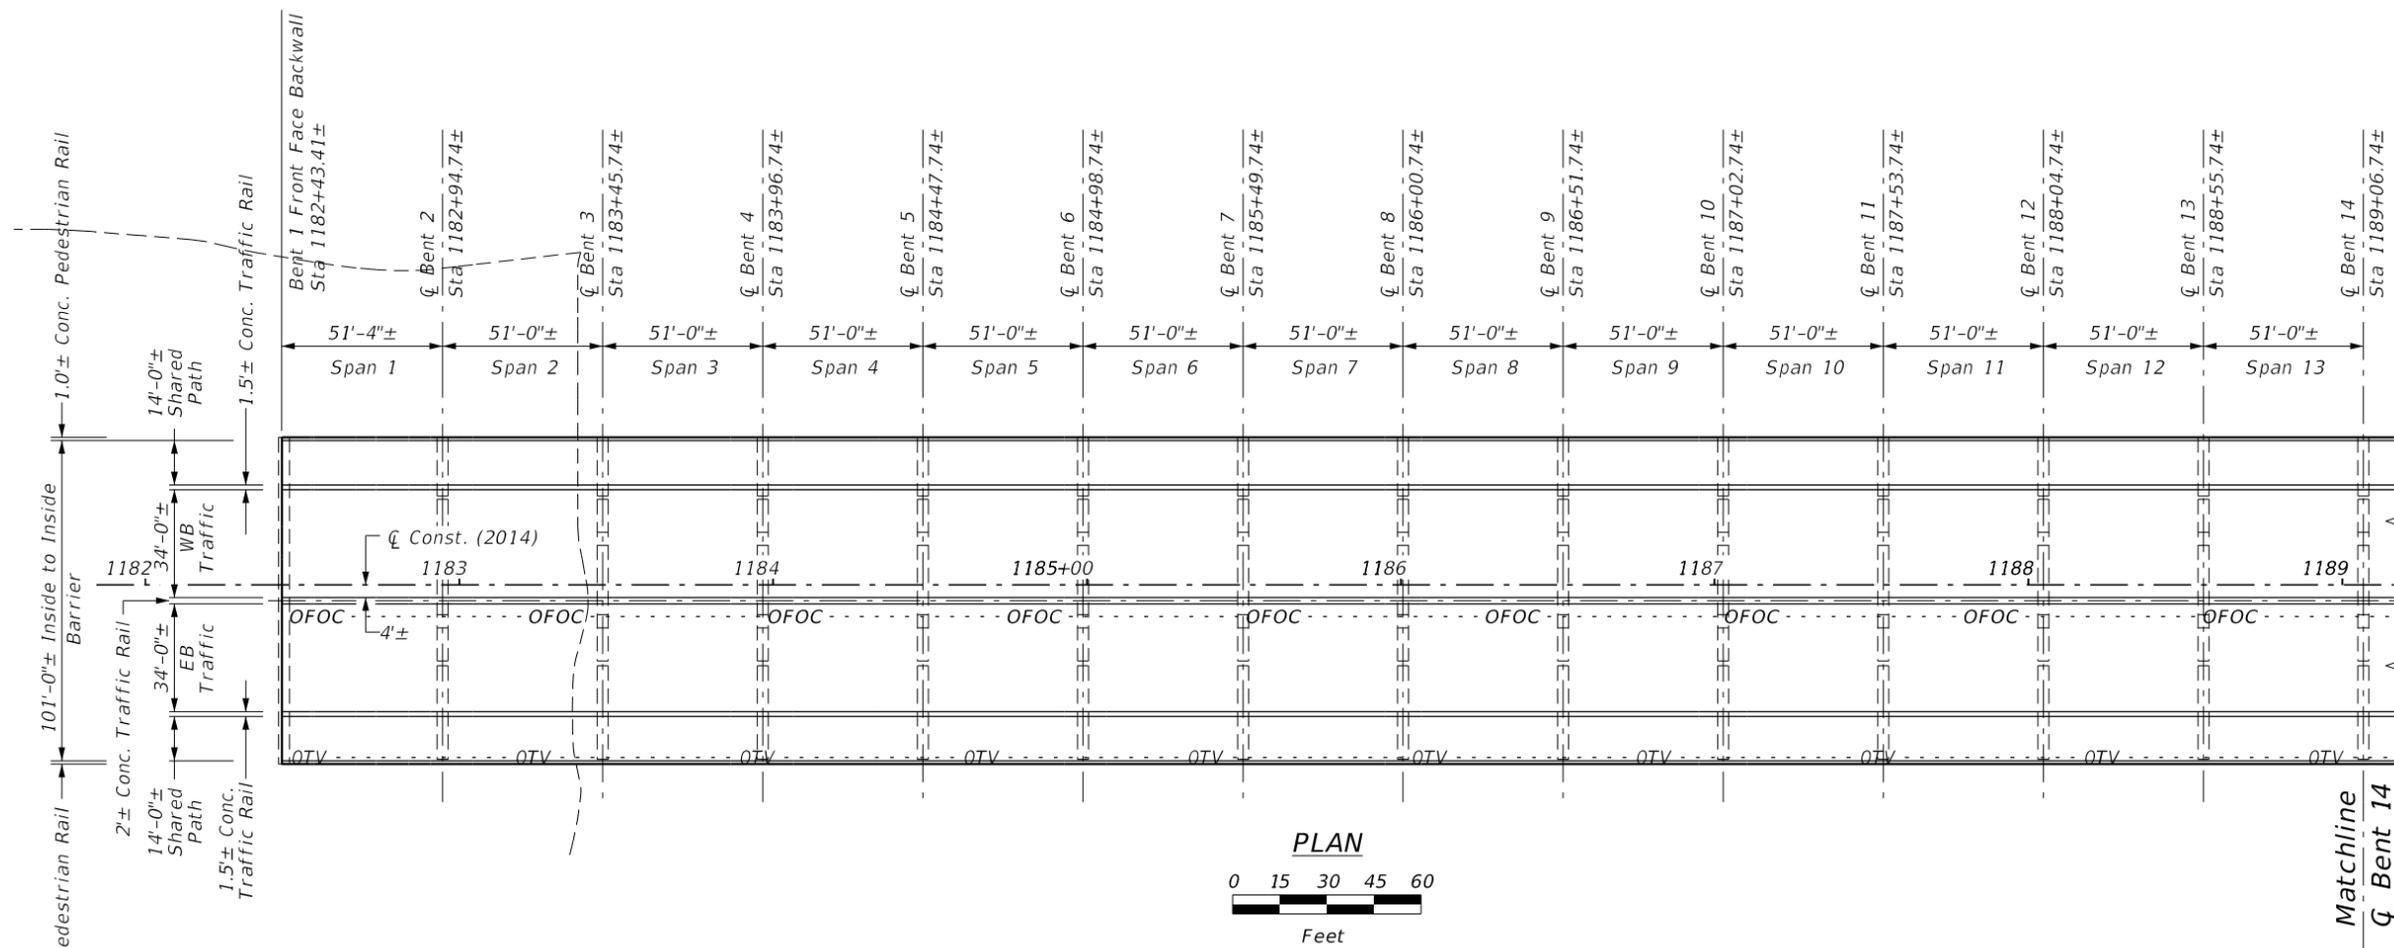
2360	ADJACENT HEADER DAMAGE
------	------------------------

6"± Wide x 3"± Depth (Typ.) Nosing to be Replaced. See General Notes for Specifications. See Sheets S-13 to S-15 for Repair Areas.

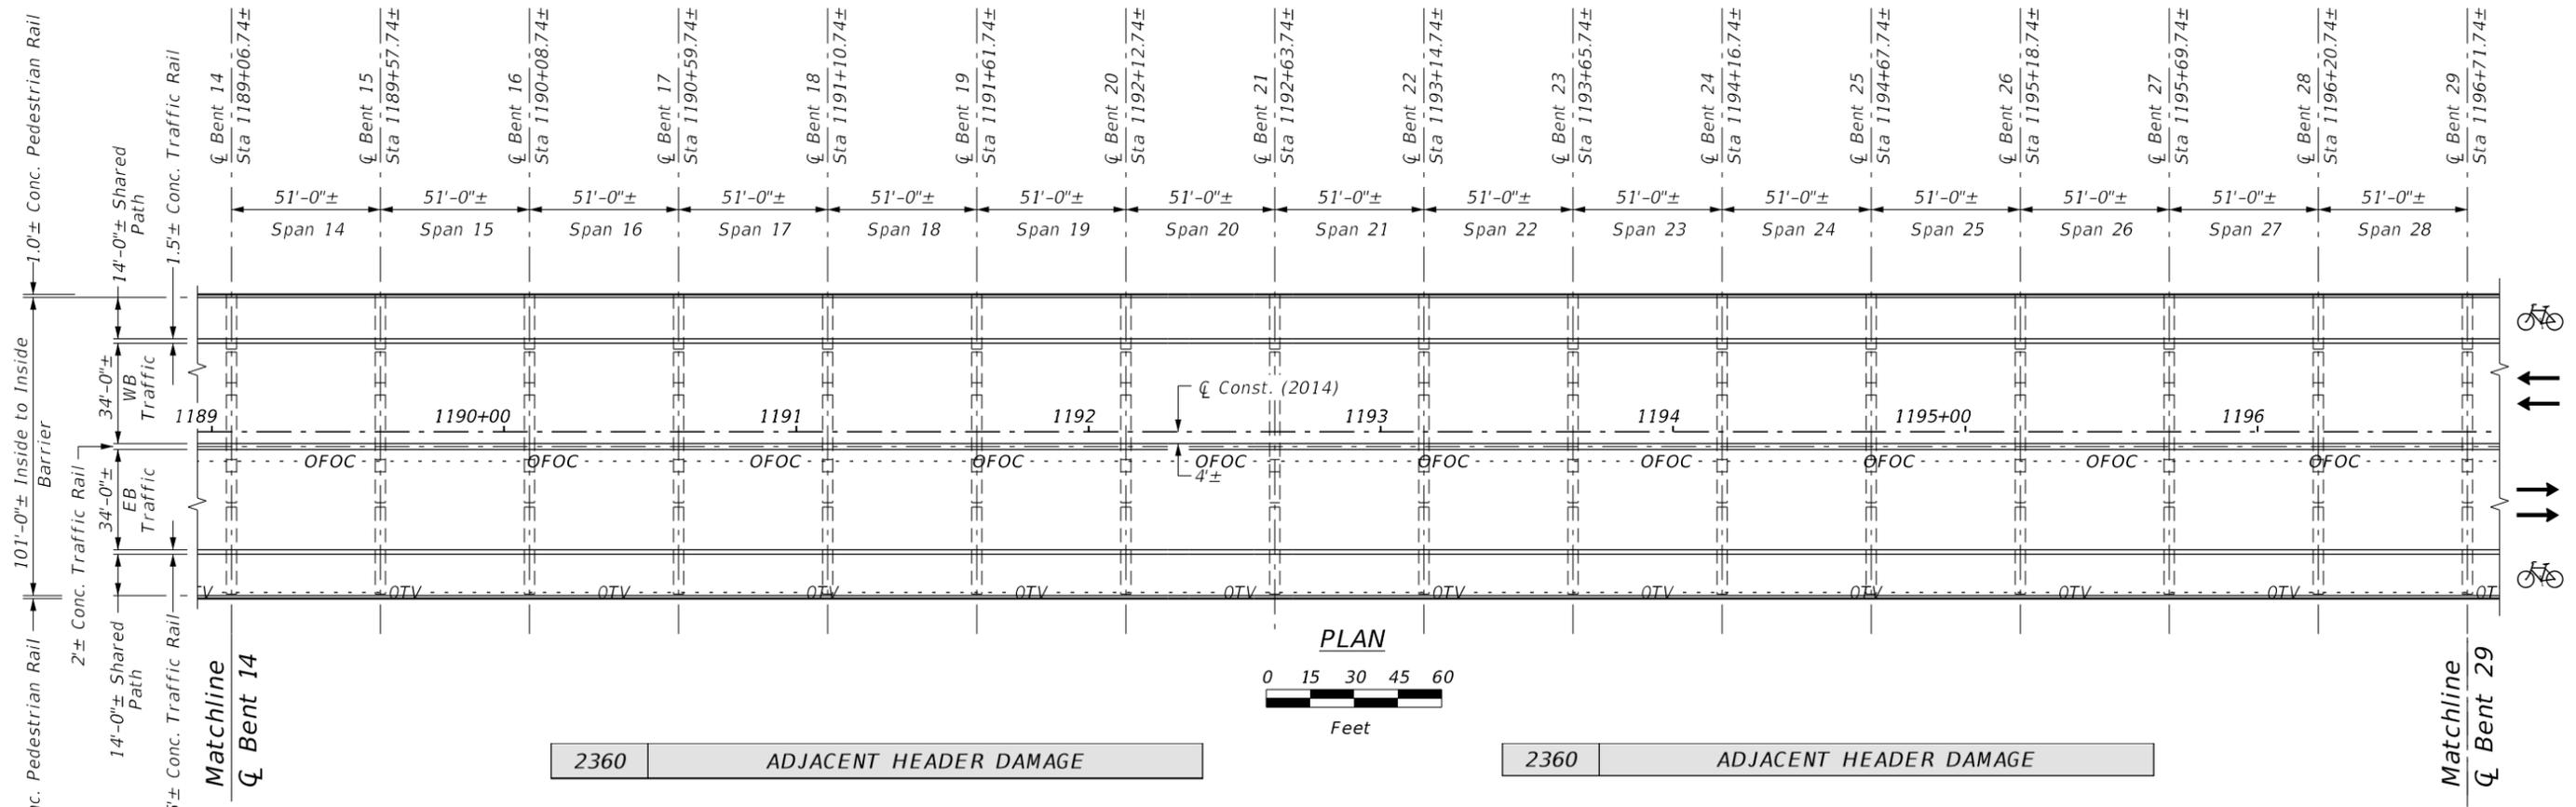
REF. DWG. NO.    SHEET NO. S-14

2360	ADJACENT HEADER DAMAGE
------	------------------------

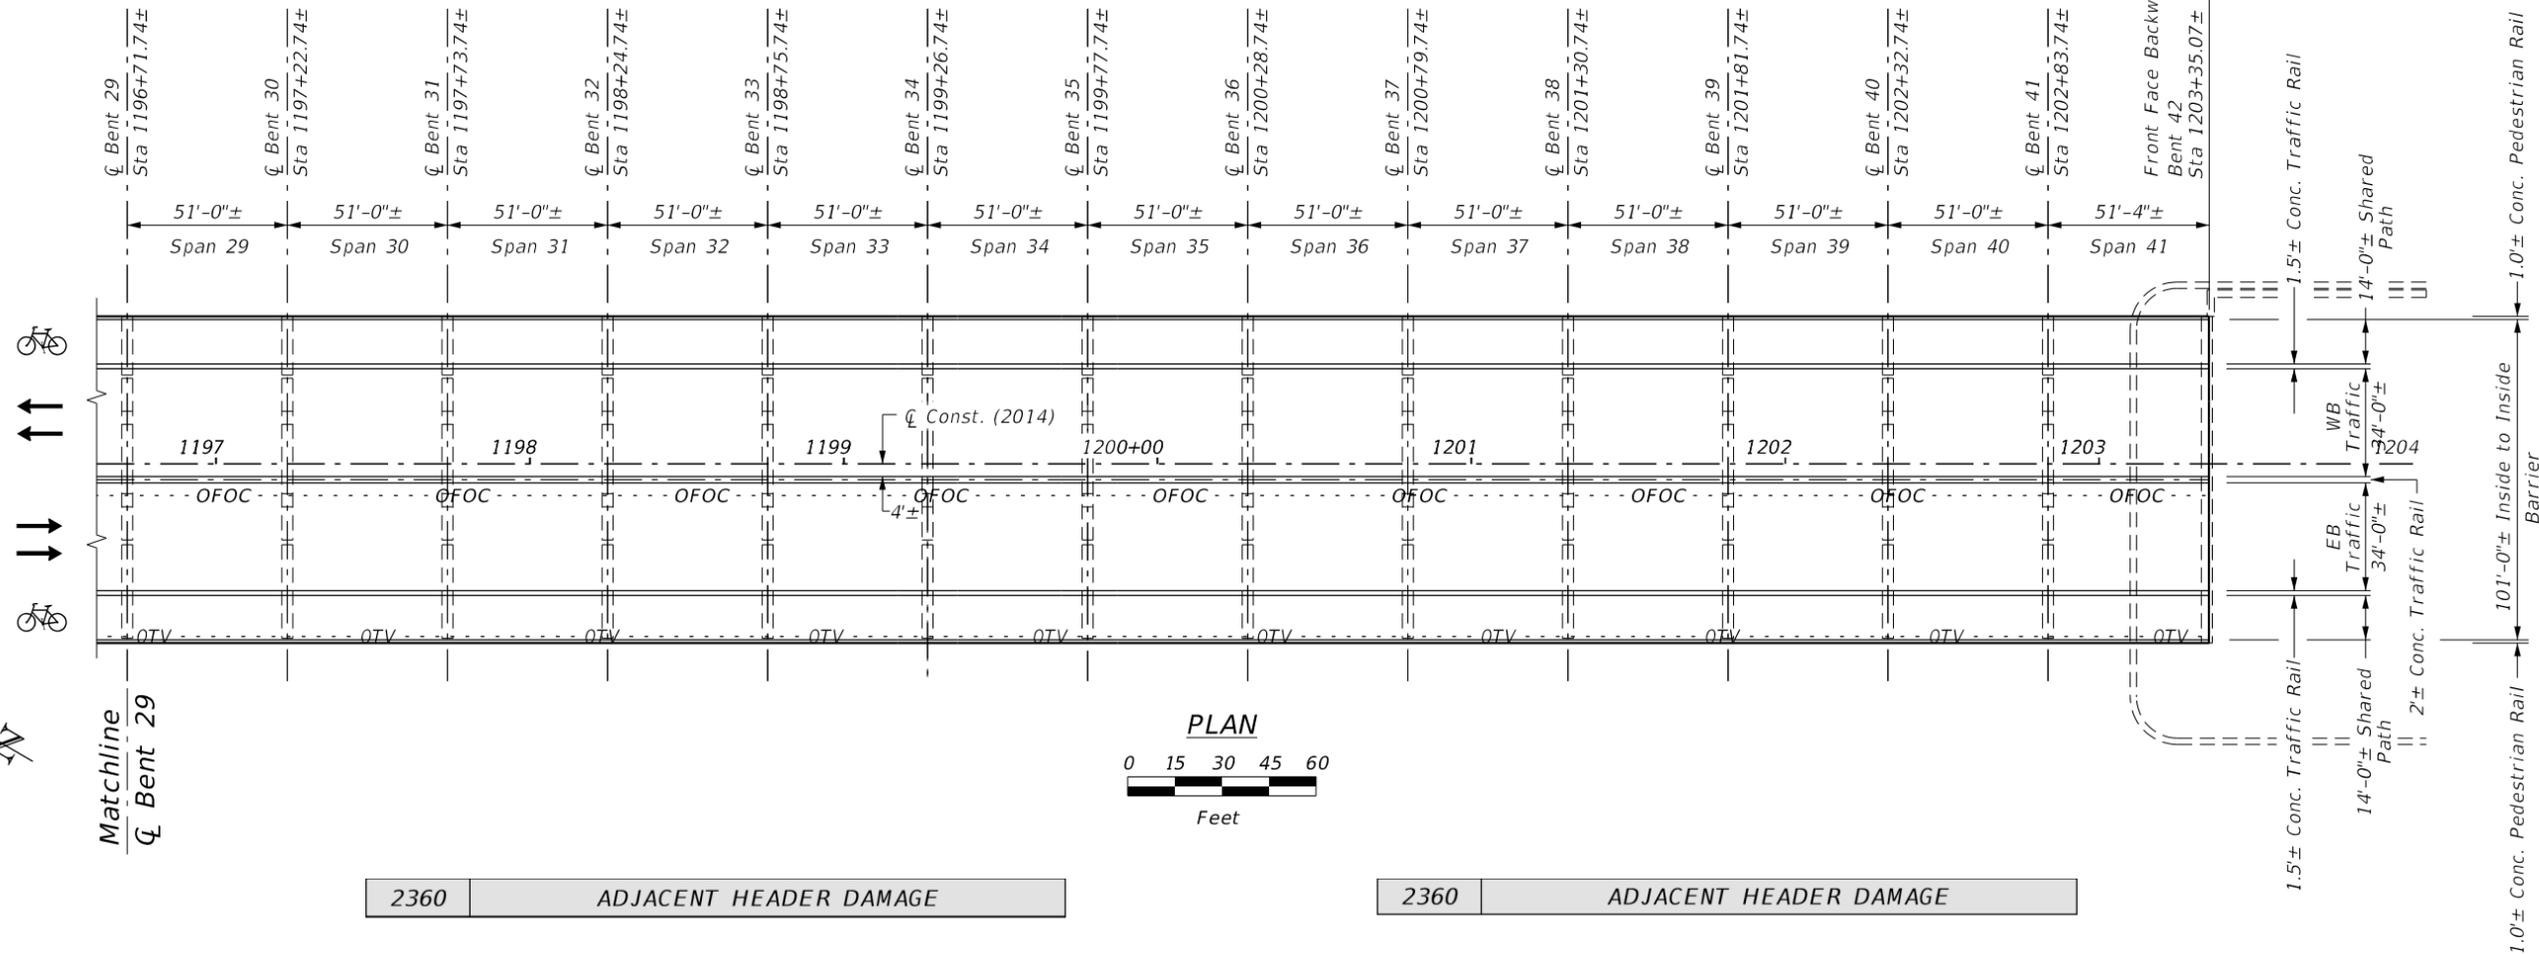
REF. DWG. NO. SHEET NO. S-15

2360	ADJACENT HEADER DAMAGE
------	------------------------
