SUNNY ISLES BEACH RESTORATION PROJECT: MECHANICAL DAMAGE
TO THE REEFS ADJACENT TO THE BORROW AREA

December 1988

Metro Dade Technical Report 88-14

Metro Dade Department of Environmental Resources Management

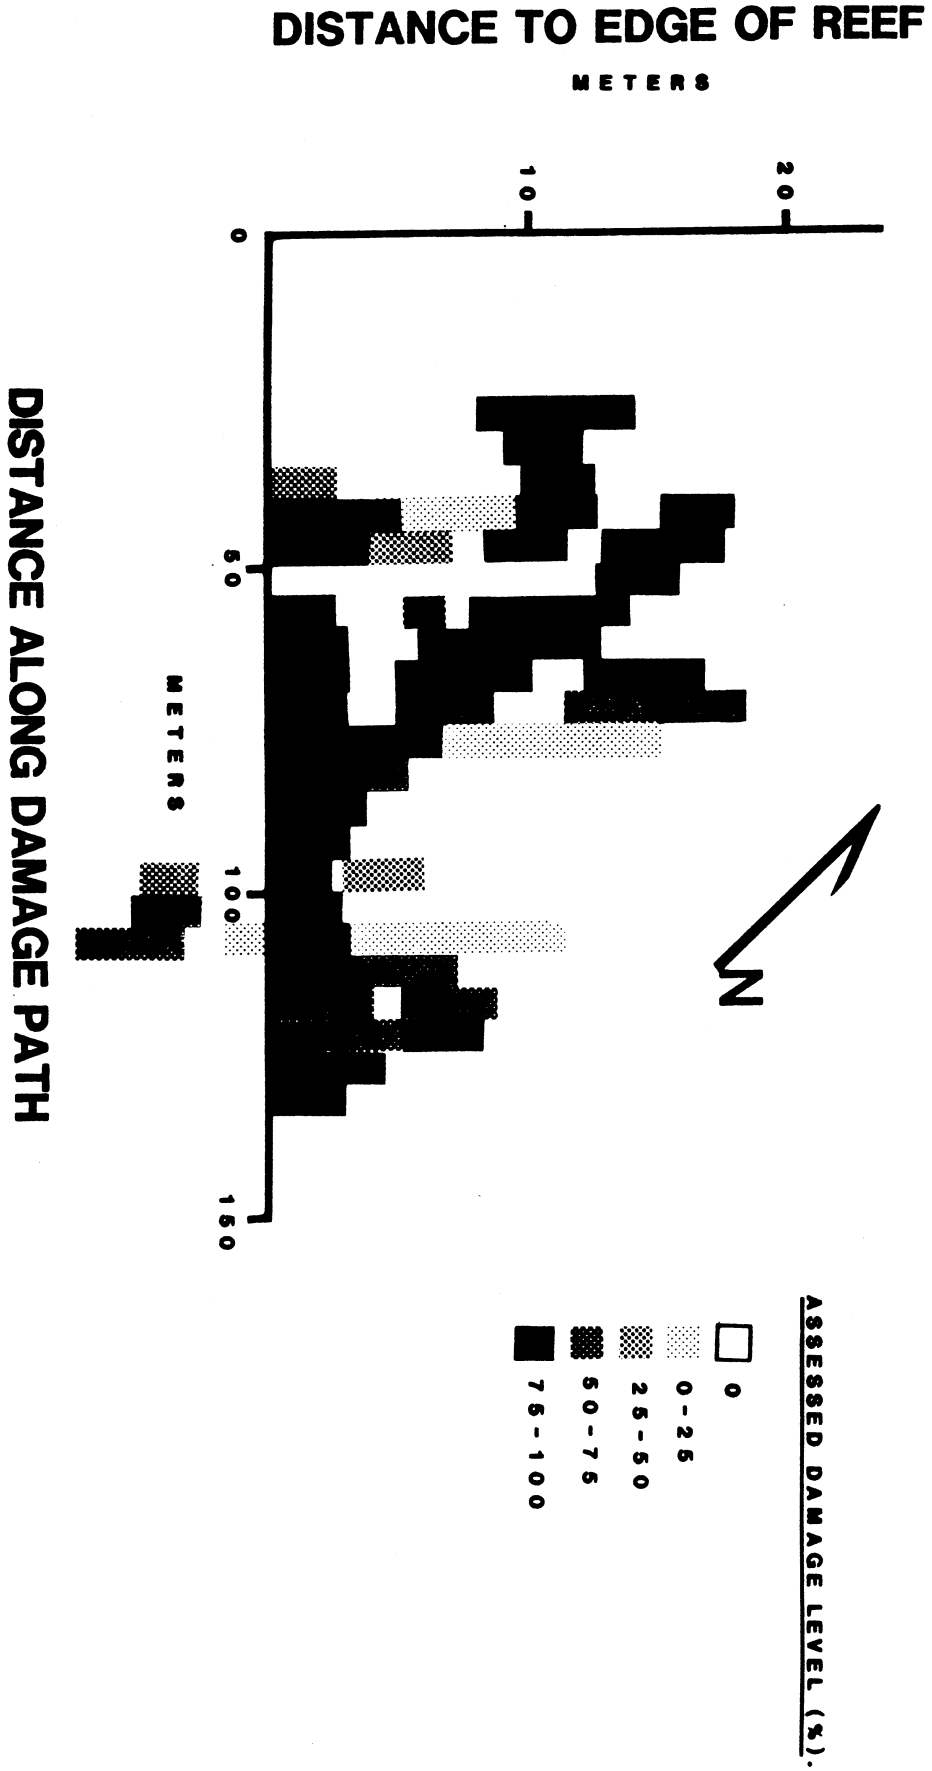
FIGURE 14

destruction was 100%. With the procedures used, however, the relative assessed loss would be calculated at a level of 87.5% (.875; Table 1). This procedure, in light of the degree and mass of damage, errors on the conservative side for the estimates of area destroyed. Figure 14 is a mosaic, generated from the calculated areas of impact and associated degrees of damage. It is apparent from the width of the area, numerous incidences of pulling the drag head over the reef had to have occurred to cause the amount of damage present.
